## **Five-Year Review Report**

### **First Five-Year Review Report for Naval Station Great Lakes Great Lakes, Illinois**

**March 2016**

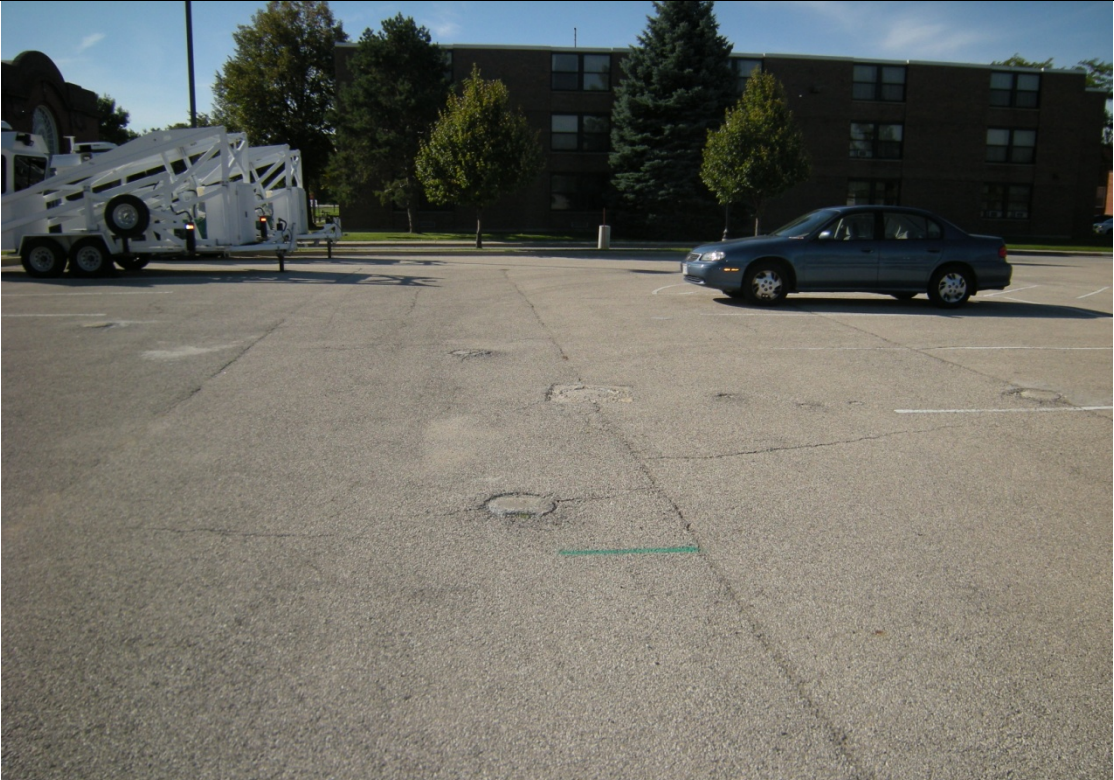
<b>Client Name:</b> Department of the Navy		<b>Site Location:</b> Naval Station Great Lakes	<b>Project No.</b> 60274656
<b>Photo No.</b> <b>1</b>	<b>Date:</b> 9/20/12

<b>Direction Photo Taken:</b>  South			
<b>Description:</b>  Engineered barrier in LUC 11, former Bldg 105, Site 22

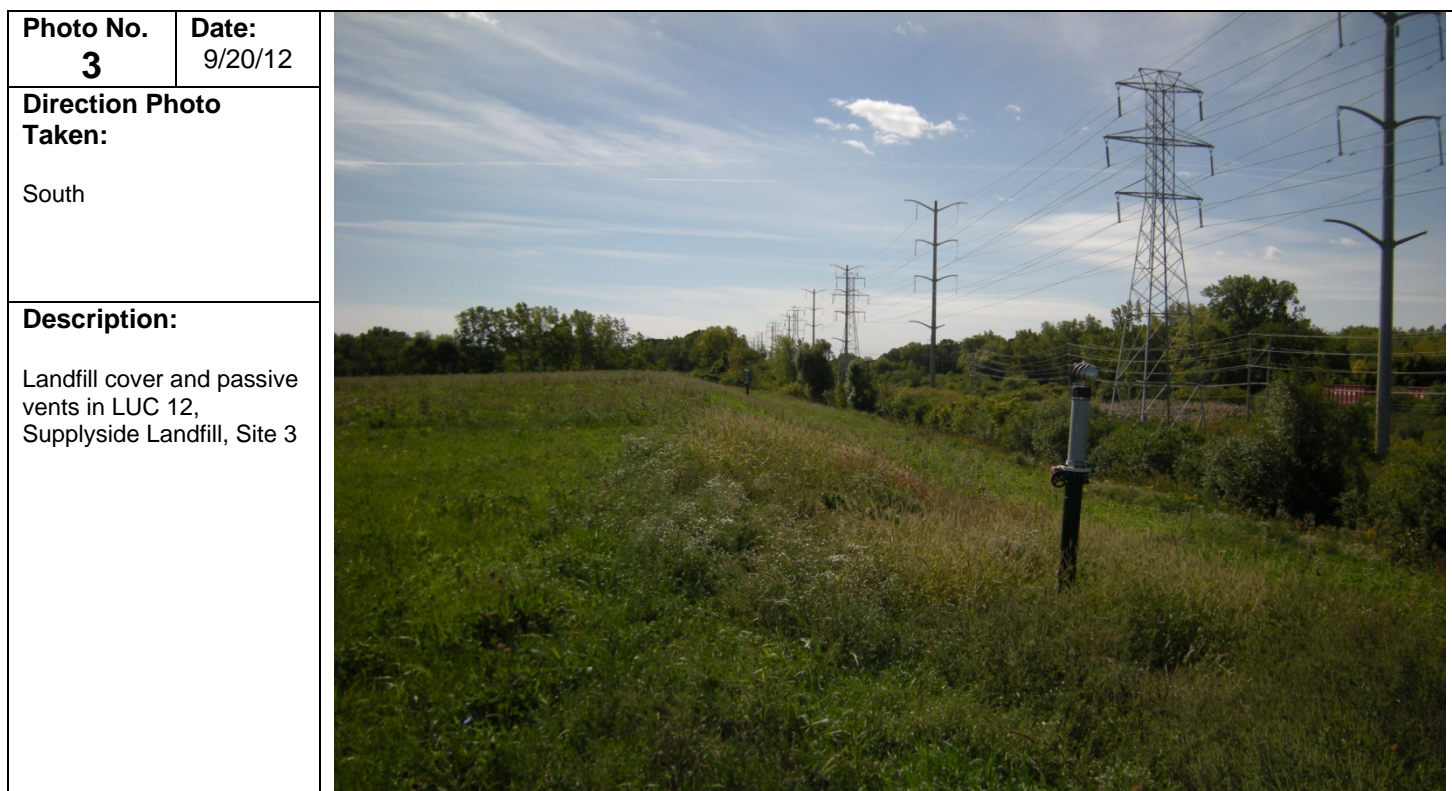
<b>Photo No.</b> <b>2</b>	<b>Date:</b> 9/20/12	 
<b>Direction Photo Taken:</b>  North		
<b>Description:</b>  Cracks in engineered barrier near monitoring wells and abandoned ERH probe locations. LUC 11, former Bldg 105, Site 22

Site 22 was also inspected on August 15, 2013, by Mr. Howard Hickey, and no property use changes to the site were noted. No evidence of breaches to the LUCs was noted, although general wear was noted on the pavement which may require maintenance. A copy of the site inspection form is included in Appendix C.

Issue	Recommendations and Follow-up Actions	Party Responsible	Oversight Agency	Milestone Date	Affects Protectiveness (Y/N)	
					Current	Future
Site 22, Former Building 105						
Monitoring wells from the investigation and ERH Treatability Study are still in place	Properly abandon all wells on the site	Navy	Illinois EPA	30 Dec 2014	N	N
